WALLKILL RIVER BASIN
ROCK ISLAND LAKE, SUSSEX COUNTY
NEW JERSEY

ROCK ISLAND LAKE DAM NJ 00819

PHASE 1 INSPECTION REPORT
NATIONAL DAM SAFETY PROGRAM

AUGUST 1981

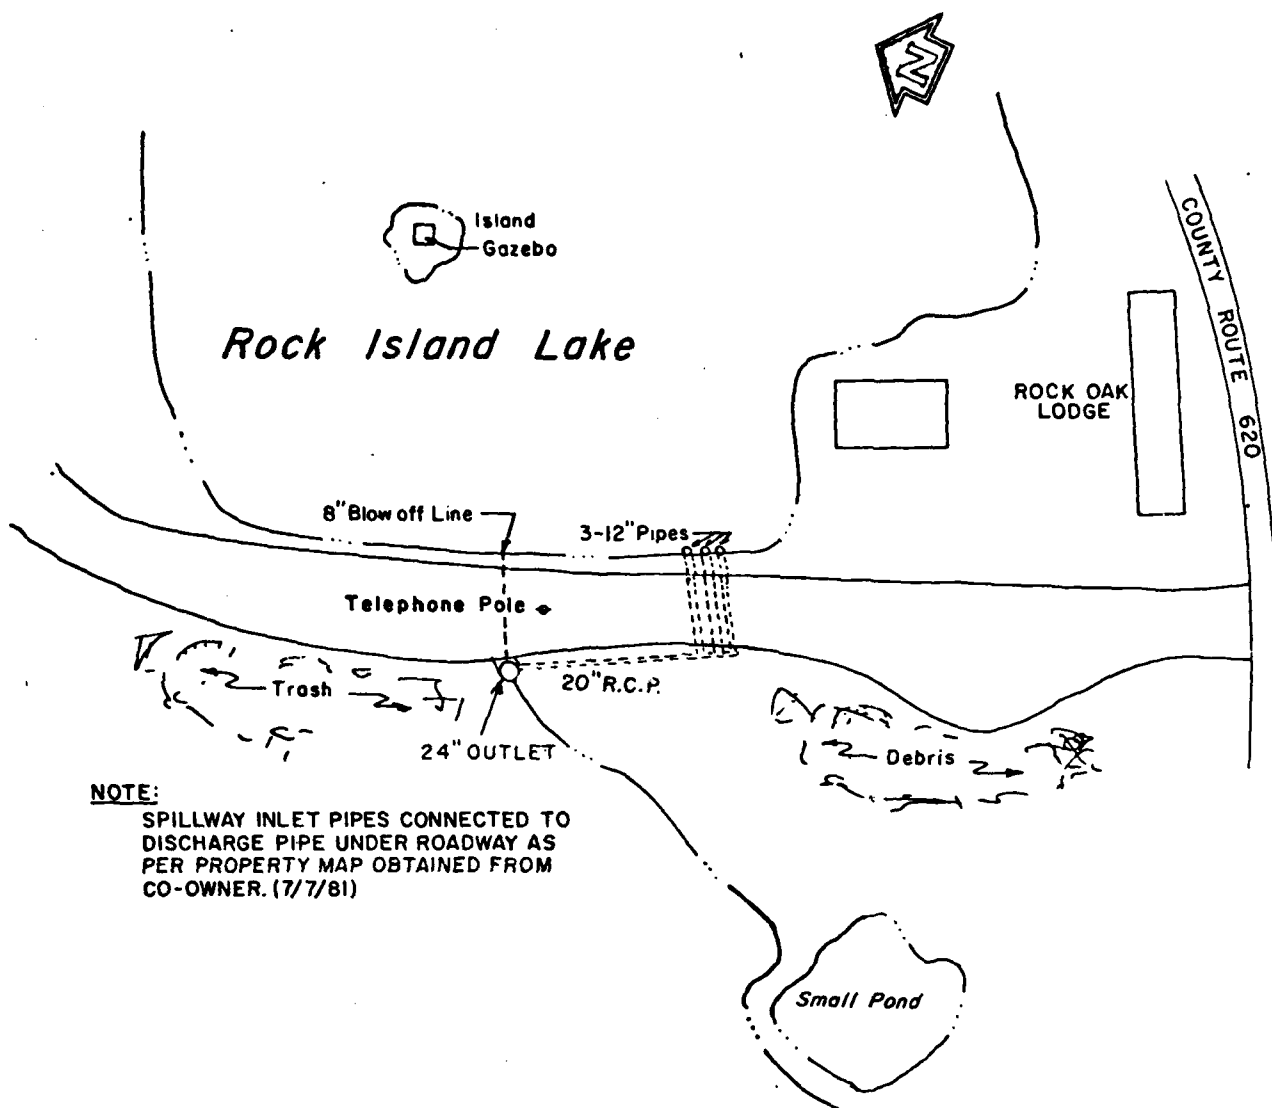
FIGURE - 1

SPILLWAY INLET PIPES CONNECTED TO DISCHARGE PIPE UNDER ROADWAY AS PER PROPERTY MAP OBTAINED FROM CO-OWNER. (7/7/81)
